Field Safety Notice 103584

Important Field Safety Notice to customers and users of Euroflex 24V electronics.

With this updated message, Eurovema Mobility AB would like to inform about safety measures for the Euroflex 24V electronic system.

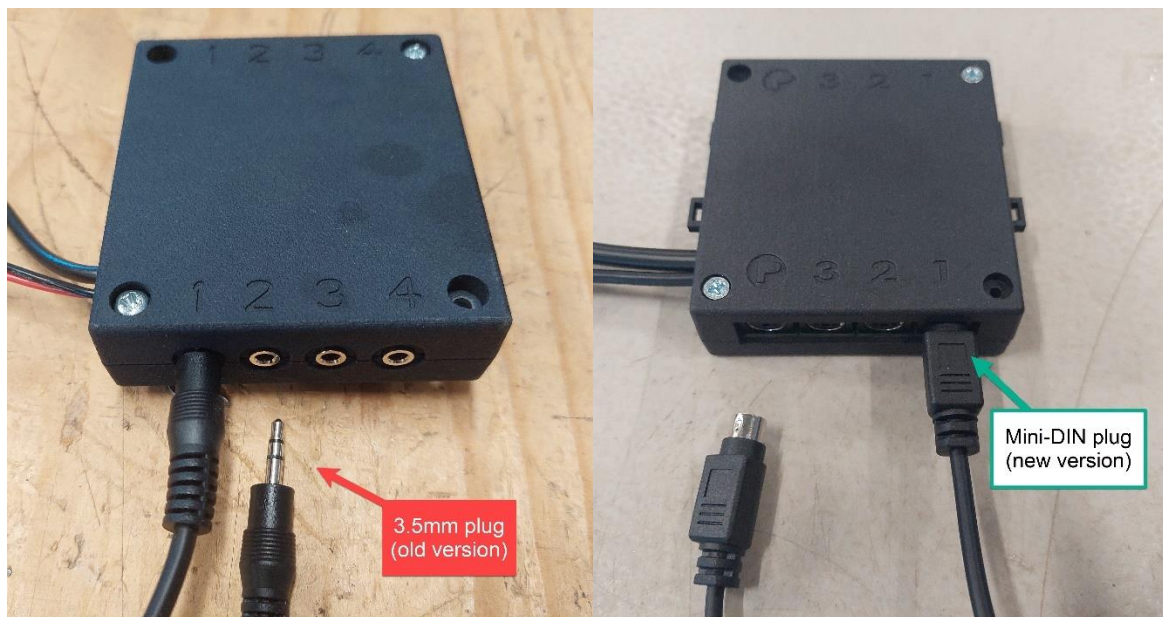
The image below depicts the old 24V electronics and the new one, as well as the differences between them.
